What Is Your Diagnosis?

In collaboration with the American College of Veterinary Radiology

History

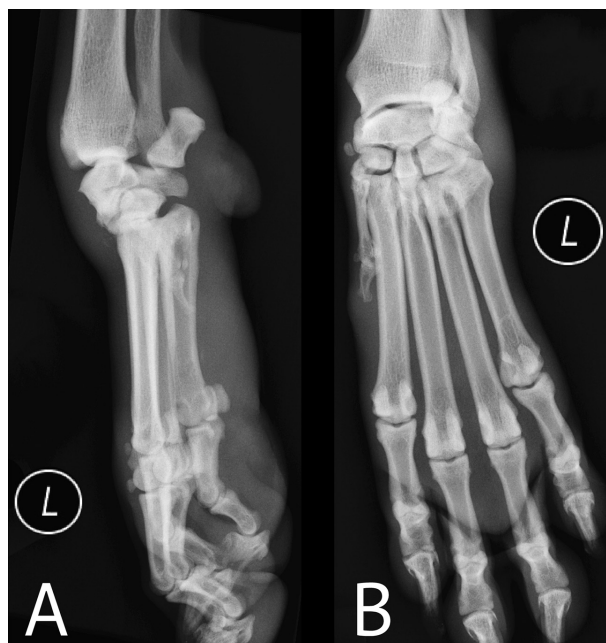
Figure 1—Mediolateral (A) and dorsopalmar (B) radiographic images of the left carpus of a 6-year-old castrated male Belgian Sheepdog with toe-touching left forelimb lameness and carpal soft tissue swelling following a 20-foot fall from a ledge.

A 6-year-old castrated male Belgian Sheepdog was presented following a 20-foot fall from a ledge onto grass. On presentation, the dog was toe-touching lame on the left forelimb, with evident swelling of the left carpus. Remaining findings on physical examination and point-of-care bloodwork were within reference limits. Two-view radiographic images of the left carpus were obtained (**Figure 1**).

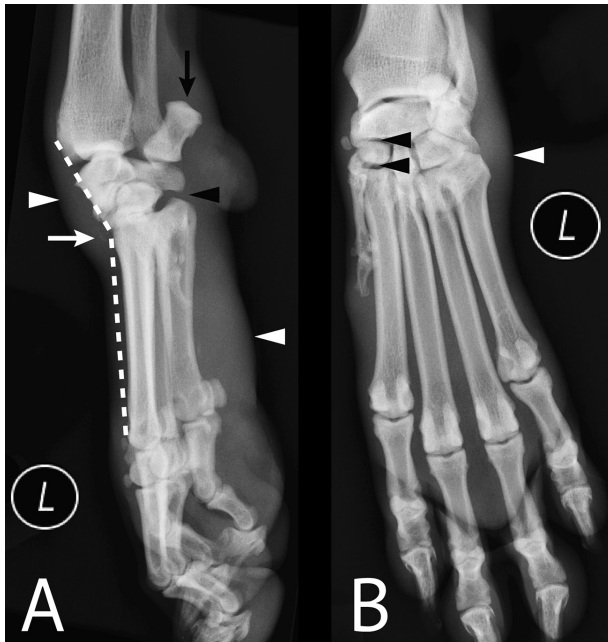
Figure 2—Same images as in Figure 1. A—The accessory carpal bone (black arrow) is rotated, with proximal displacement of its palmar aspect. The palmar aspect of the carpometacarpal joint space is widened (black arrowhead). The carpometacarpal joints are hyperextended (dashed line). There is ill-defined mineral material immediately dorsal to the distal row of carpal bones (white arrow). B—There is mild widening of the medial aspect of the middle carpal joint and the articulation between the second carpal and metacarpal bones (black arrowheads). There is also moderate soft tissue swelling palmar to the metacarpal bones and surrounding the carpus on both views (white arrowheads).

The accessory carpal bone was rotated, with the palmar aspect of the bone proximally displaced, indicating disruption of the accessory metacarpal ligaments (**Figure 2**). The palmar aspect of the carpometacarpal joint space was widened, and the carpometacarpal joints were hyperextended, indicating disruption of the palmar fibrocartilage. A small amount of ill-defined, mineral material was evident immediately dorsal to the distal row of carpal bones; this may have represented small bone fragments or cutaneous debris. On the dorsopalmar view, there was mild widening of the medial aspect of the middle carpal joint and the articulation between the second carpal and metacarpal bones, suggestive of injury to the medial collateral ligament of the carpus. Moderate soft tissue swelling was evident surrounding the carpus and palmar to the metacarpal bones. These findings were consistent with carpal hyperextension injury.

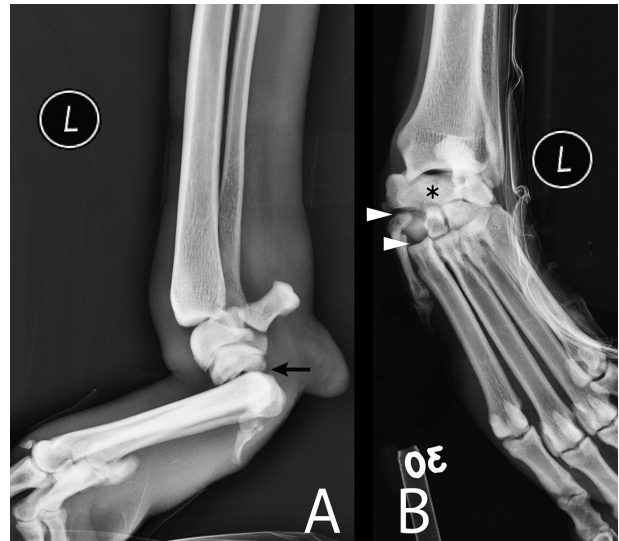
Figure 3—Mediolateral and dorsopalmar radiographic images of the left carpus of the dog described in Figure 1, with the carpus positioned in hyperextension (A) or medial stress applied (abduction of the manus with the antebrachium fixed in place; B). A—The carpometacarpal joints are subluxated (black arrow). B—The medial aspects of the middle carpal and carpometacarpal joints are widened (white arrowheads), and there is mild subluxation of the radiocarpal joint, with medial displacement of the intermedioradial carpal bone (asterisk) relative to the distal aspect of the radius.

The next day, radiographic images of the affected joint with stress applied (stress radiographs) were obtained: a mediolateral view of the left car-

pus positioned in hyperextension and dorsopalmar views of the left carpus positioned with medial stress (abduction of the manus with the antebrachium fixed in place) and then with lateral stress (adduction of the manus with the antebrachium fixed in place). On the hyperextended view, the carpometacarpal joints were subluxated, with marked palmar rotation of the proximal aspects of the metacarpal bones relative to the distal row of carpal bones (**Figure 3**). On the medial stress view, the medial aspects of the middle carpal and carpometacarpal joints were widened, confirming injury to the medial collateral ligament of the carpus. There was also mild subluxation of the radiocarpal joint evident on this view, with medial displacement of the intermedioradial carpal bone relative to the distal aspect of the radius. There were no meaningful findings on the lateral stress view (not shown).

For the dog of the present report, radiographic findings, particularly on the stress views, were useful in the evaluation and subsequent surgical repair of the dog's carpal hyperextension injury. Although the dog's hyperextension injury was evident as rotation of the accessory carpal bone and widening of the palmar aspect of the carpometacarpal joint space on the initial radiographic images, the severity of the instability was not fully appreciated until a hyperextended view was acquired. Furthermore, medial collateral ligamentous injury was confirmed by the widening of the medial aspect of the middle

carpal and carpometacarpal joints and radiocarpal joint subluxation on the medial stress dorsopalmar view. For cases in which carpal hyperextension injury is suspected (acute non-weight-bearing forelimb lameness with carpal soft tissue swelling and no evidence of fractures), stress radiography is useful to fully evaluate the severity of instability.
